NBSIR 76-1044 (R)

Selected Problems Related to the Storage of Mobile Homes for Use as Disaster Housing

April 1976

Final Report

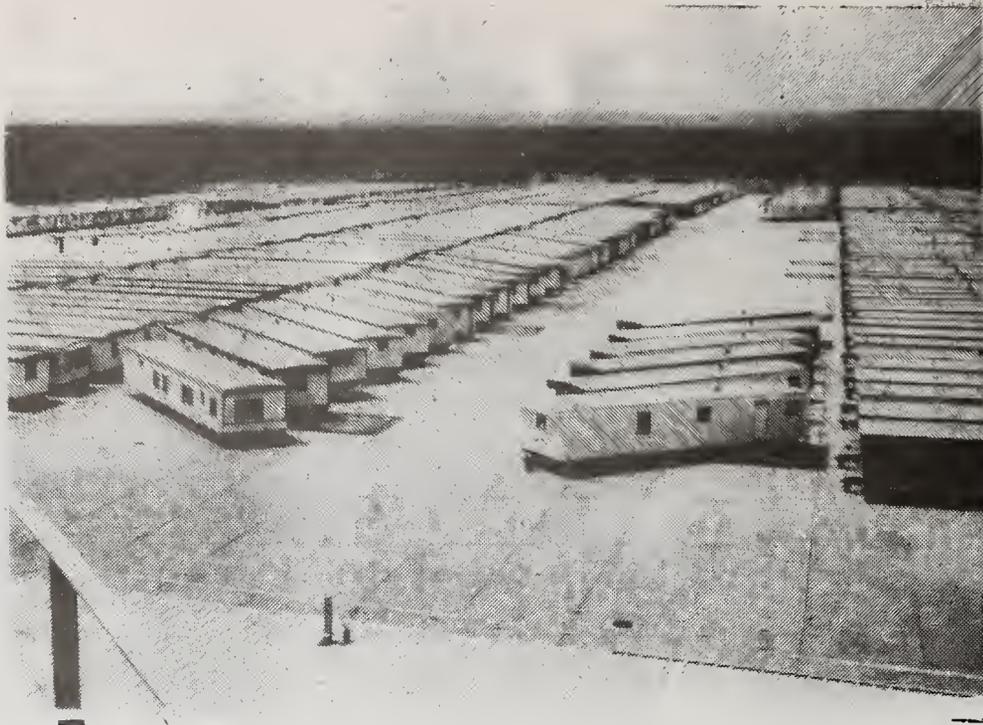
The terrain of the storage center would have a significant effect on the method of anchorage system selected. A level and paved site such as Dempsey SSC (figure 1) would be more desirable for the storage and anchorage of mobile homes than a hilly site such as Blue Grass SSC (figure 45).

Figure 1 Stored Mobile Homes (Dempsey, Texas)

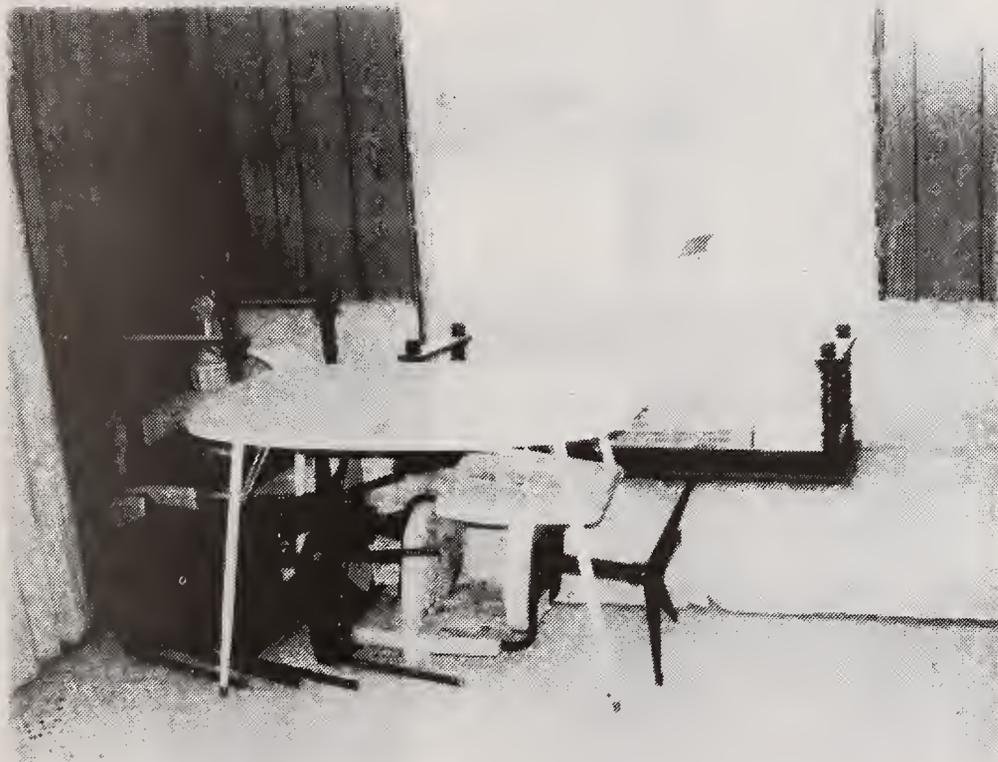
Figure 13 Revised Upright Storage of Furniture to Reduce Moisture and Mildew Problems

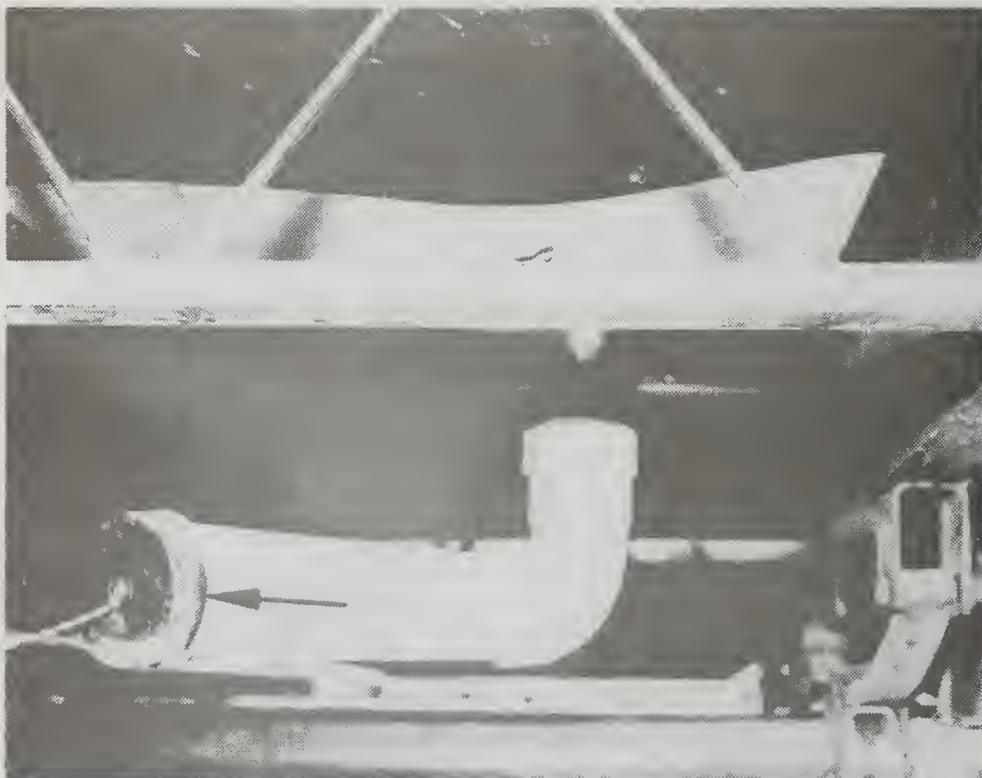
Figure 23 Sewer Outlet With End Capped; Sheet Metal Bottomboard Patch

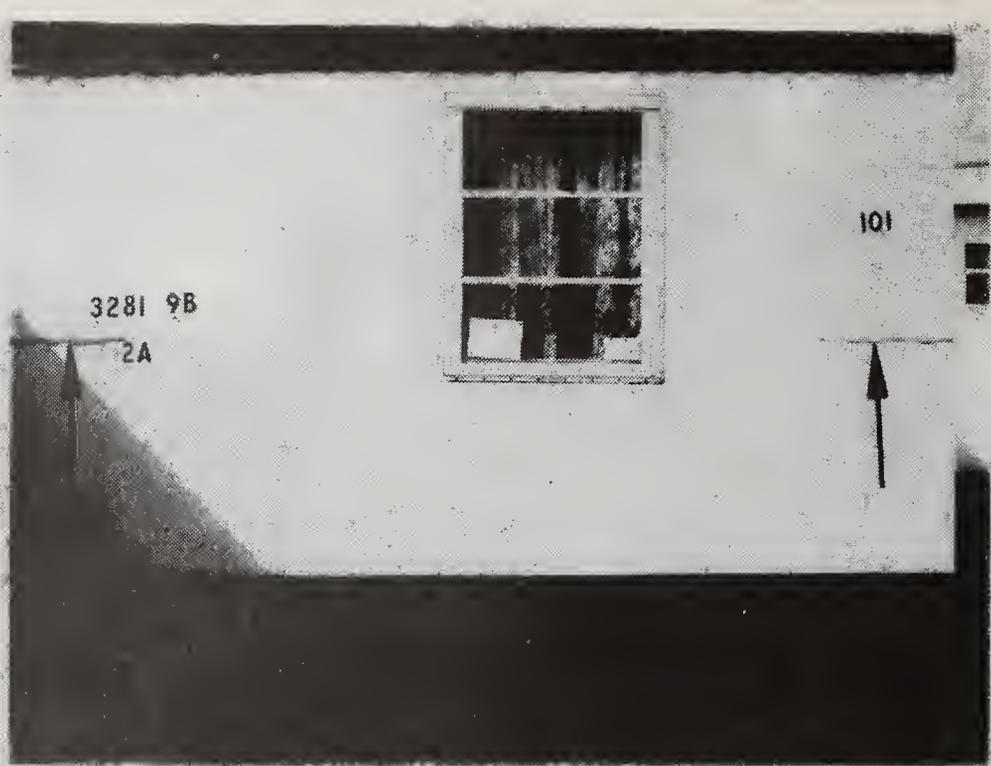
The metal strapping, secured at mid-height of the front wall and extending back a distance of eight feet on both longitudinal side walls of the mobile home (figure 30) is presently used at the SSC's. It appears to be quite effective in reducing metal skin damage caused by wind forces encountered in transit.

Figure 30 Strapping to Prevent Siding Peelback During Transport

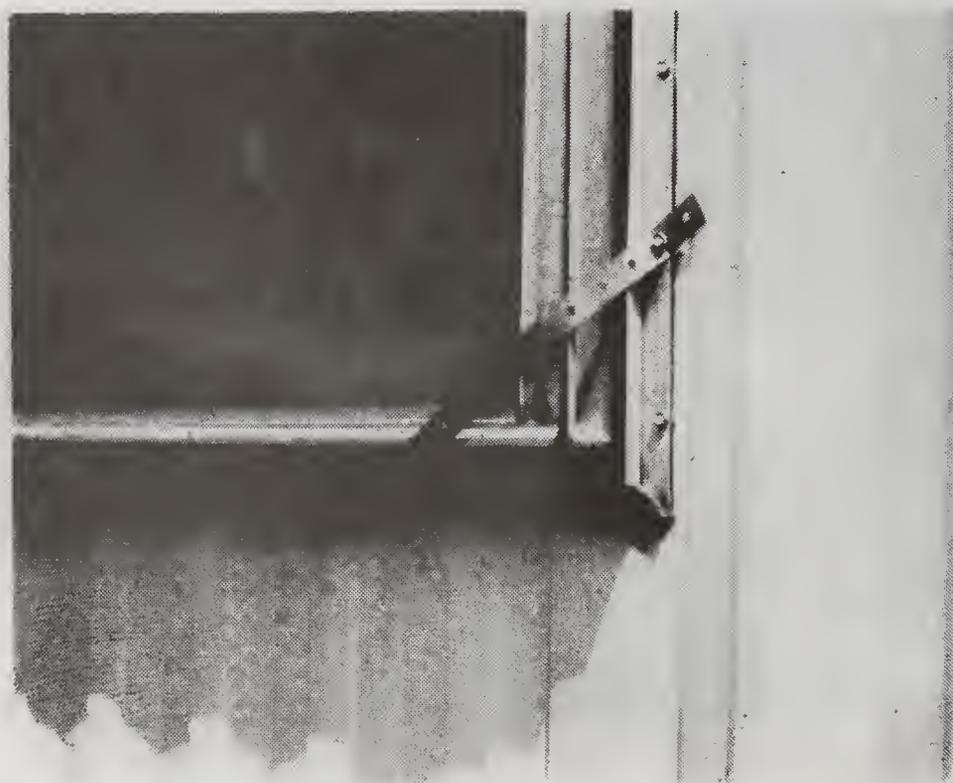
Figure 35 Pipe Strapping Used to Keep Awning Window Closed

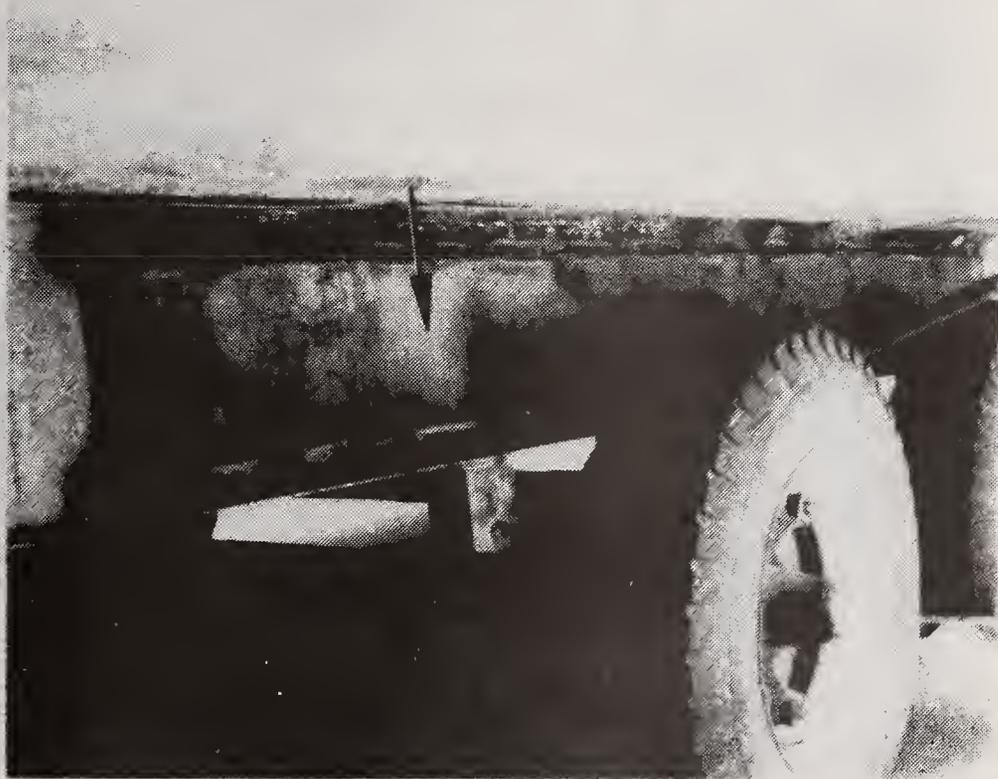
At several of the SSC's visited, recambering of mobile home longitudinal beams is being accomplished by selectively applying heat and welding additional plate reinforcement to structural members at critical stress areas over the axles (figure 37). Ten mobile homes listed as recambered were inspected. Visual observation of some recambered units brought to question the effectiveness of recambering mobile home "I" beams which have experienced excessive vertical deflection. Some data on the experience of these units when next transported are needed.

Figure 37 Plate Reinforcement Welded to Re-cambered I-Beam

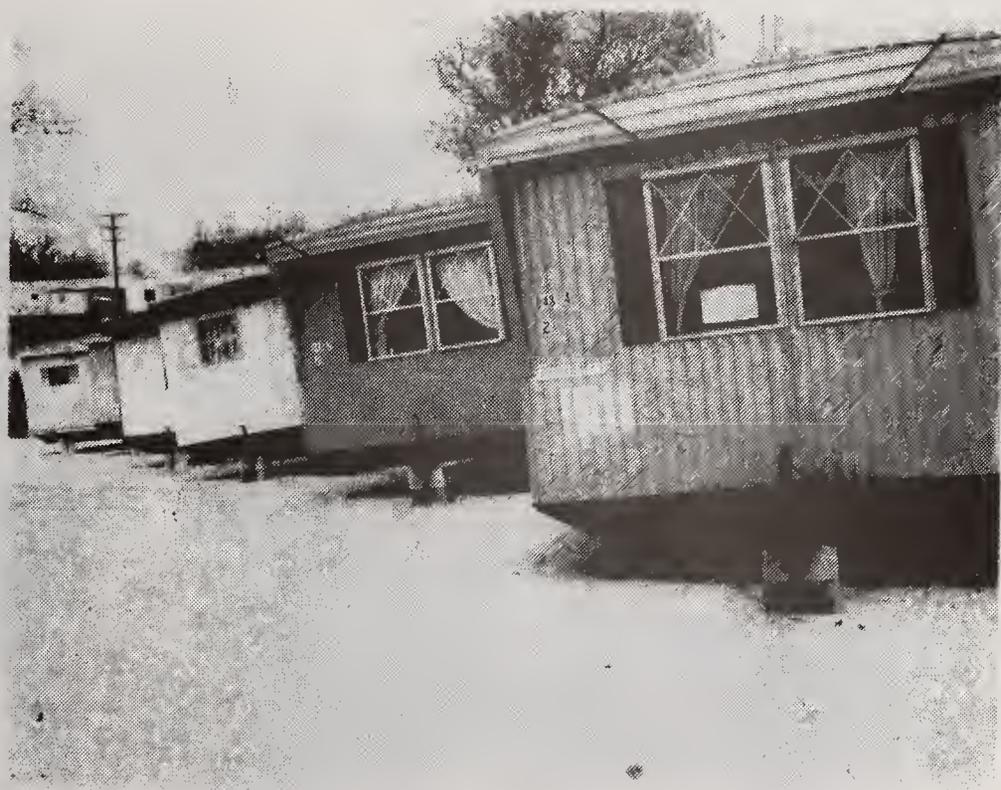
Figure 45 Storage of Mobile Homes on Sloping Site
(Blue Grass SSC)
